# CASE STUDY

### STRATFORD RACECOURSE

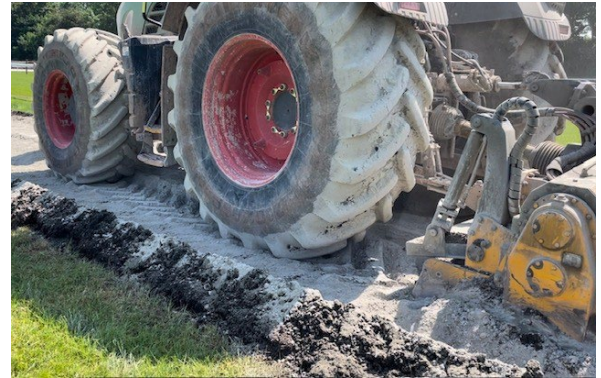
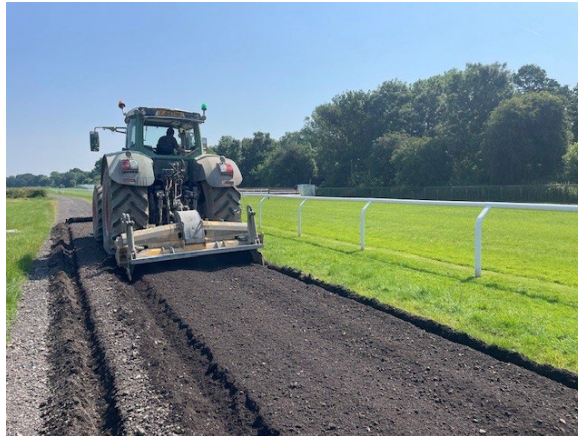
At Stratford racecourse sections of the surface of the perimeter road had become loose and were beginning to develop potholes.

The existing surface was crushed in-situ using an addition of cement.

Once the sections had been crushed and mixed they were graded to the correct level and then compacted.

After compaction, addition water was added and the final surface was power floated.
